ALABAMA HAZARDOUS WASTES MANAGEMENT AND MINIMIZATION ACT (AHWMMA)
Compliance Evaluation Inspection (CEI) Report

Mesker Door, ~~LLC Inc. (Mesker)~~
3440 Stanwood Blvd. NE
Huntsville, (Madison County), Alabama 35811

March 15, 2017

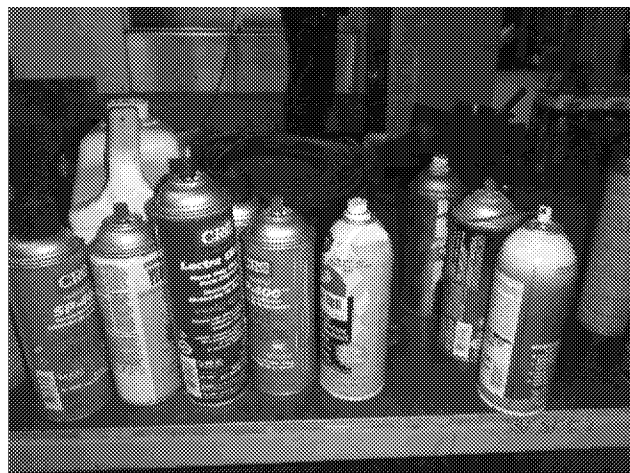
First, Mr. Chandler escorted us to the Maintenance Area. In this area, we observed several aerosol cans that were discarded in the trash not punctured (see Photograph #1). No other areas of concern were noted in the Maintenance Area.

Photograph # 1: Maintenance Shop – Aerosol cans discarded in the garbage

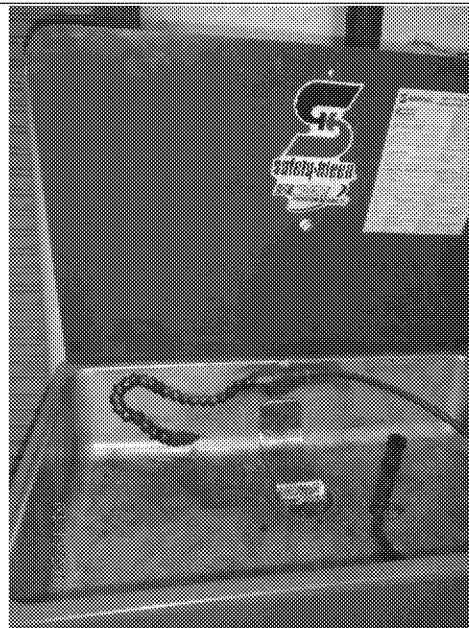
Next, Mr. Chandler escorted us to the Compressor Room area. In this area, we observed a Safety Kleen Systems solvent parts washer (see Photograph #2). The parts washer was observed not connected and no longer in use at the time of the inspection. No areas of concern were noted in this area at the time of the inspection.

Photograph #2: Compressor Room – Safety Kleen Systems part washer

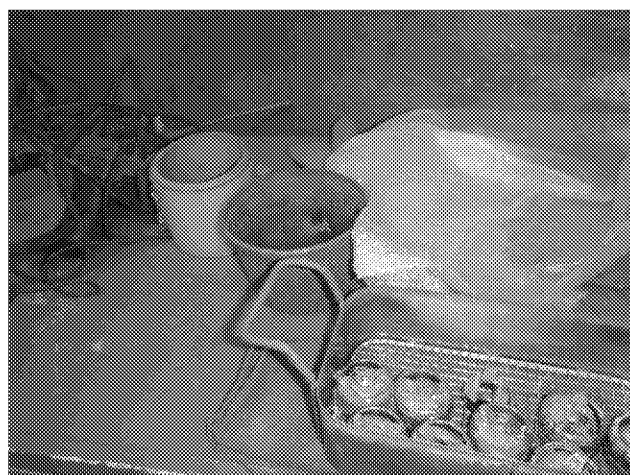
Next, Mr. Chandler escorted us to the Paint Booth Area. In this area, we observed one metal yellow fireproof cabinet that contained aerosol cans for touch up paint jobs and degreasers. In the same area staged on a metal shelf, we observed a plastic cup of paint nozzles for the automatic spray booth soaking in solvent (see Photograph #3). According to Mr. Ben Jeglum, Paint Line Lead, the paint filters in the front of the paint booth are changed three times a week and the filters in the back are changed every two weeks when a peel coat is done. He also mentioned that a water-based paint is used often and a butyl cellosolve is occasionally used. A water flush is also conducted when a new paint is used and when the facility switches to a new vendor. The liquid waste is stored below in the Paint Kitchen and is picked up by Safety Kleen Systems, Inc. (TXR000081205). According to Mr. Chandler and Mr. Jeglum, the paint used at Mesker is non-hazardous, but a hazardous waste determination has not been conducted.

Photograph #3: Paint Booth – Cup of nozzles soaking in solvent

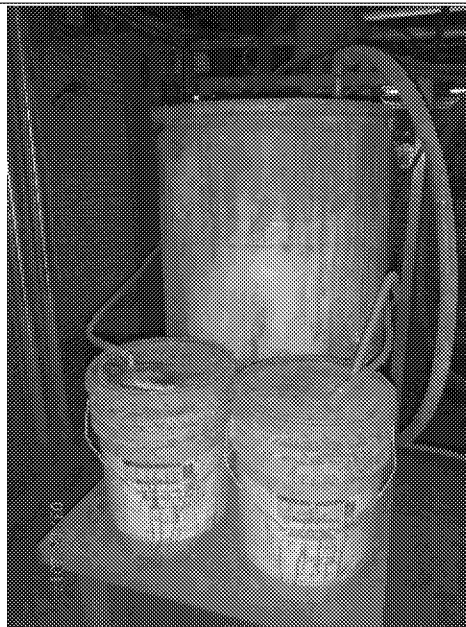
Next, we were escorted below to the Paint Kitchen. In this area, we observed one plastic 55-gallon drum of water with a hose connected to two 5-gallon containers designated for discarded water (see Photograph #4). This system is the water flush from the Paint Booth Area. Once the discarded water from the 5-gallon containers are full, they are then emptied into a 55-gallon drum of liquid waste (see Photograph #5). In this area, we also observed an aerosol can discarded in the garbage can designated for the Paint Kitchen Area (see Photograph #6).

Photograph #4: Paint Kitchen – Liquid waste collection containers and clean water drum

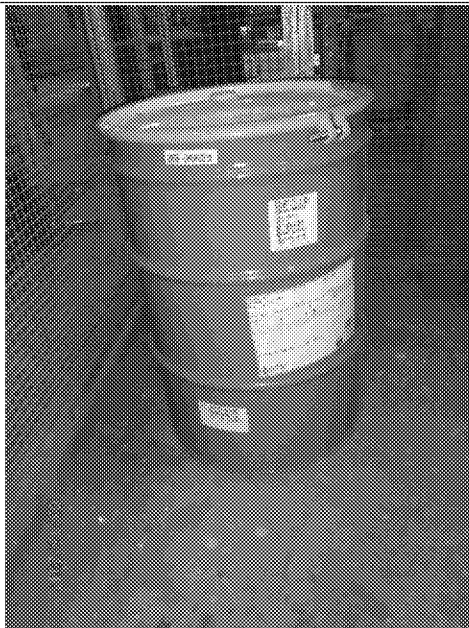
Photograph #5: Paint Kitchen – Liquid waste drum

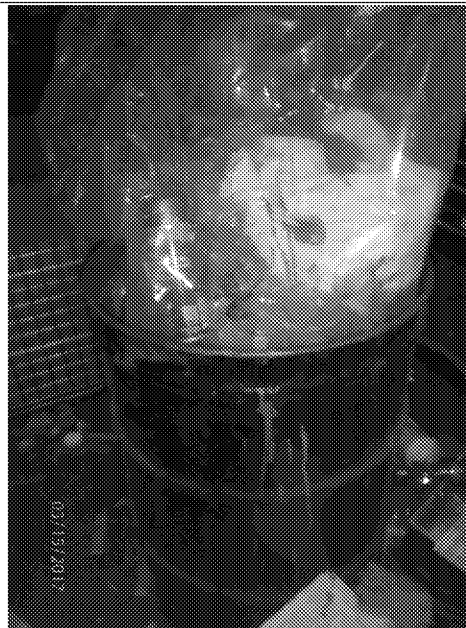
Photograph #6: Paint Kitchen – Garbage can with a discarded aerosol can

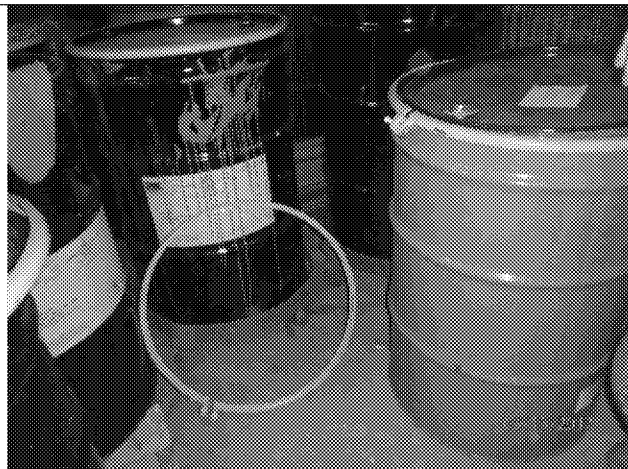
Next, we were escorted to the Flow Coat Process area. In this area, a holding tank pumps fresh paint that is applied to the doors staged on the assembly line. According to Mr. Jeglum, the pump system is flushed out every two weeks. The paint in this area is recycled, approximately 150 gallons a month. The spray nozzles for applying the paint are re-used and the galvanized piping is replaced and disposed of with the scrap metal. In this area, we observed two 55-gallon drums of liquid waste in the Flow Coat Process area waiting to be moved to the storage area. The two 55-gallon drums were not labeled or dated (see Photograph #7).

Photograph #7: Flow Coat Process – Two drums of liquid waste, not labeled or dated

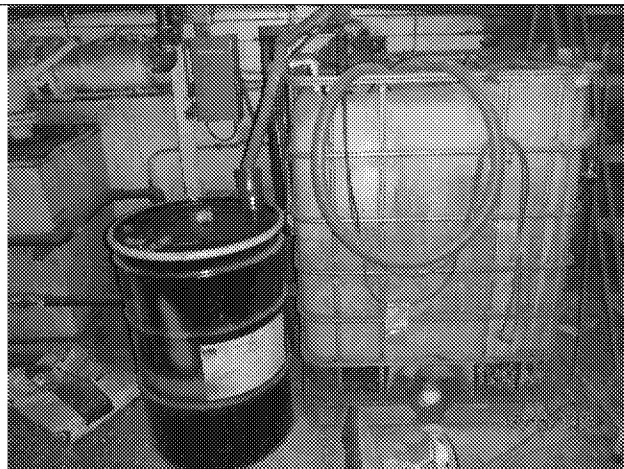
Next, we were escorted to the Wash Line Area. A conveyor carries the parts (door skins and frame pieces) into the first stage of the wash line which is heated to around 90 degrees and contains an additive chemical, ZP3 to remove dirt and oil from parts. The water and sludge from stage one is pumped out about every 12-18 months by Safety-Kleen Systems and are handled accordingly. No hazardous waste determination has been conducted on the sludge. The stage two has no chemicals added to it, but residual is carried over on each part from stage one. Stage three is strictly a clean water rinse. In this area, near the stage one wash line, we observed an oil skimmer connected to a 250-gallon tote containing used oil and one 55-gallon drum of used oil in the same area. Both the drum and tote were not labeled with the words "Used Oil" (see Photograph #8) and the tote was not closed (see Photograph

3. One 55-gallon drum and one 250-gallon tote containing used oil not labeled with the words "Used Oil" staged at Stage 1 wash line area;
4. One 55-gallon drum labeled with the words "Waste Oil" staged in the Chemical Room was not labeled with the words "Used Oil";

Photograph #8: Stage 1 – Oil skimmer tote and used oil drum not labeled

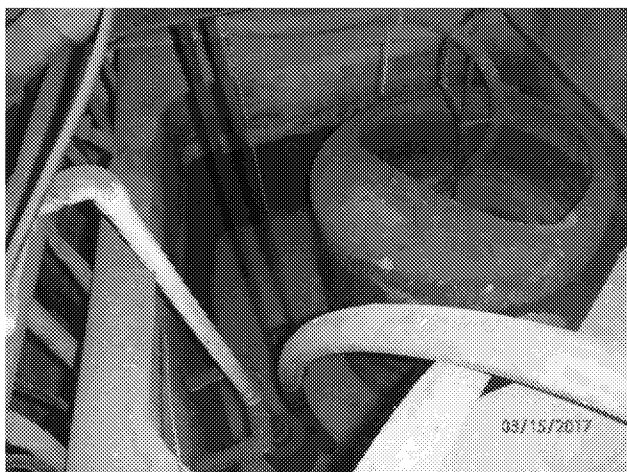
Photograph #9: Stage 1 – Oil skimmer tote not closed

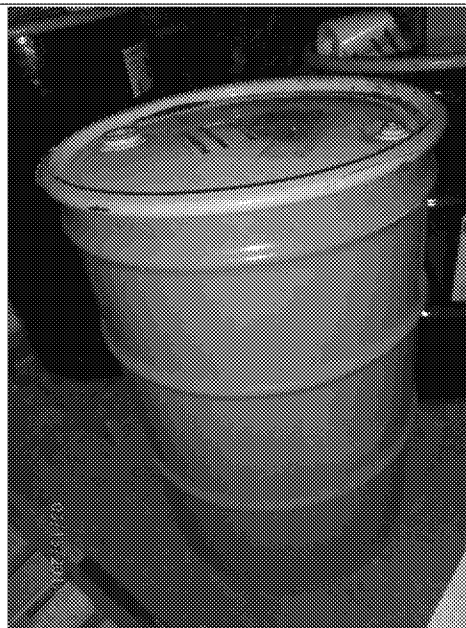
Photograph #10: Chemical Storage – 55-gallon drum of floor waste

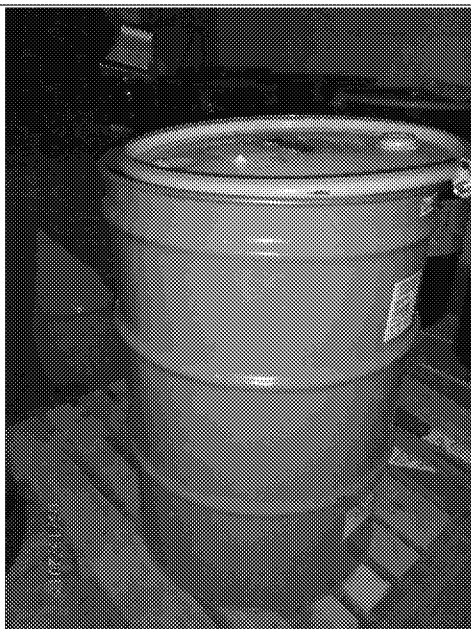
Photograph #11: Chemical Storage – 55-gallon drum labeled "Partial Waste" and dated "3/6/17"

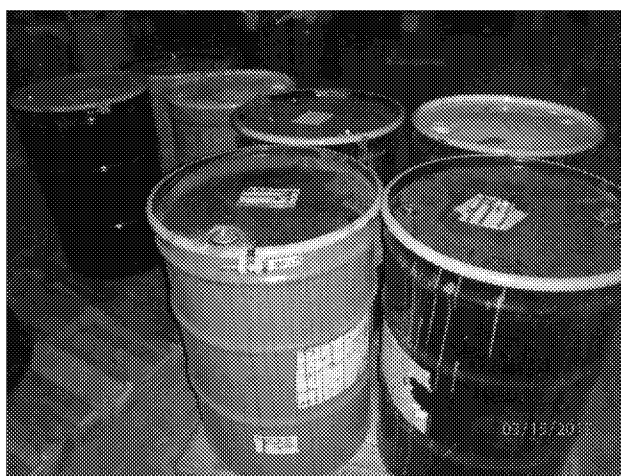
Photograph #12: Chemical Storage – waste drums

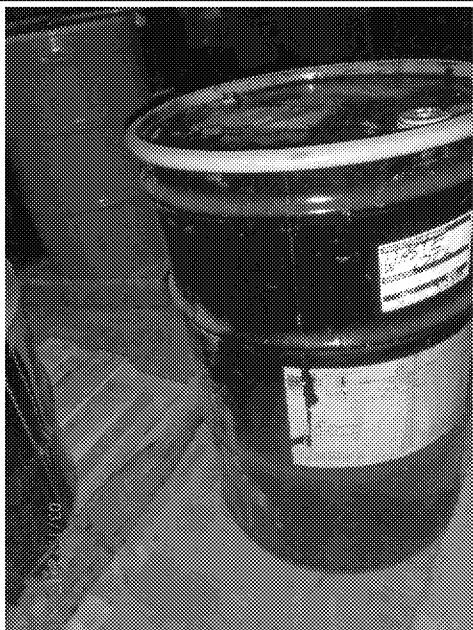
Photograph #13: Chemical Storage – waste oil

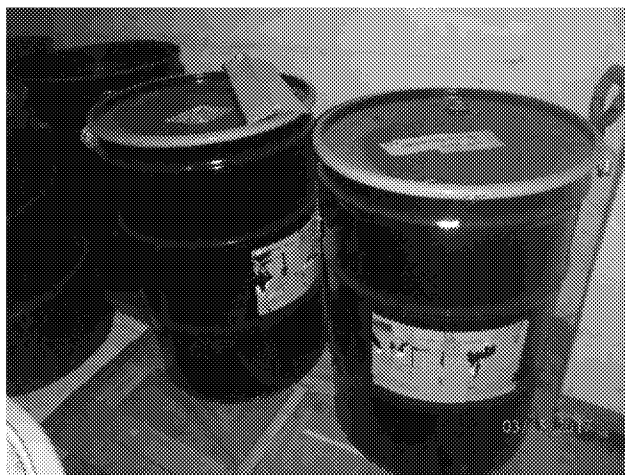
Last, we were escorted to the Chemical Storage Room. In this area, we observed the following: one 55-gallon drum containing floor waste, one 55-gallon drum containing partial waste, five 55-gallon drums containing liquid paint waste, two 55-gallon drums containing an unknown material, one 55-gallon drum containing waste oil, and two 55-gallon drums of bad paint. According to Mr. Chandler, the 55-gallon drum labeled with the words "Floor Waste" is mop water. The date was not legible on the drum (see Photograph #10). The 55-gallon drum containing partial waste was approximately half full, labeled with the words "Waste Partial", marked with "3/6/17" for an accumulation start date, and not closed (see Photograph #11). The five 55-gallon drums containing liquid waste, mop water, or waste water were all marked with the words "Liquid Waste", "Waste Water", or "Mop Water", closed, and marked with "2/27/17, 3/1/17, 3/6/17, 3/6/17, and 3/7/17" for accumulation start dates (see Photograph #12). The one 55-gallon drum containing oil was labeled with the words "Waste Oil", instead of "Used Oil" (see Photograph #13). The two 55-gallon drums of bad paint were both labeled with the words "Bad Paint/Being Returned" and dated "1/26/17" (see Photograph #14). The remaining two 55-drums were not marked or labeled to identify the contents inside or dated.

Photograph #14: Chemical Storage – Bad paint drums

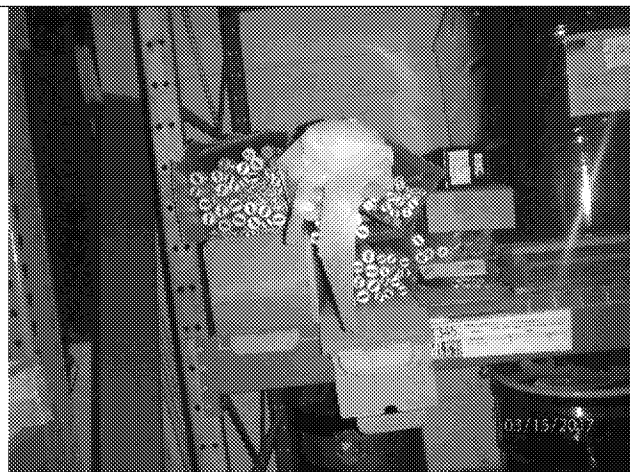
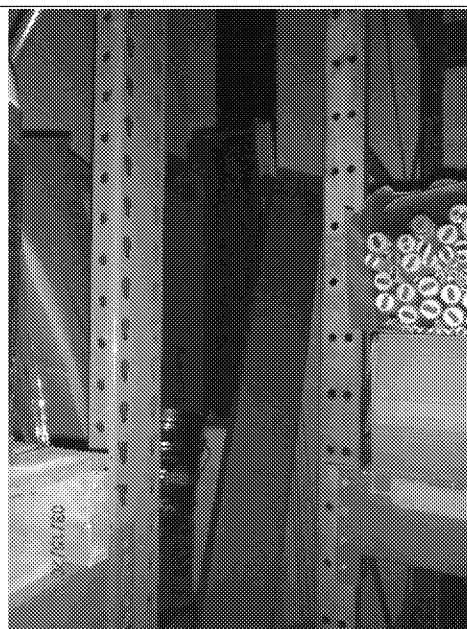
In this area we also observed, six cardboard boxes of 4-foot used fluorescent lamps staged on a shelf at the back of the Chemical Storage Room, two 8-foot boxes of used fluorescent lamps, and three used 8-foot fluorescent lamps not in container staged in the corner of the room (see Photograph #15 and #16). None of the boxes were labeled with the words "Universal Waste" or marked with an accumulation start date. Five of the six-foot boxes and both of the 8-foot boxes of fluorescent lamps were observed open during the inspection. We also observed one 55-gallon drum containing fluorescent bulb waste and one blue storage bin containing bad ballasts observed under the shelf (see Photograph #17). The 55-gallon drum was labeled with the words "Fluorescent Bulb Waste", but not closed or marked with an accumulation start date. The storage bin was labeled with the words "Bad Ballasts" and not marked with an accumulation start date.

Photograph #15: Chemical Storage – Universal waste lamps

Photograph #16: Chemical Storage – Universal waste lamps

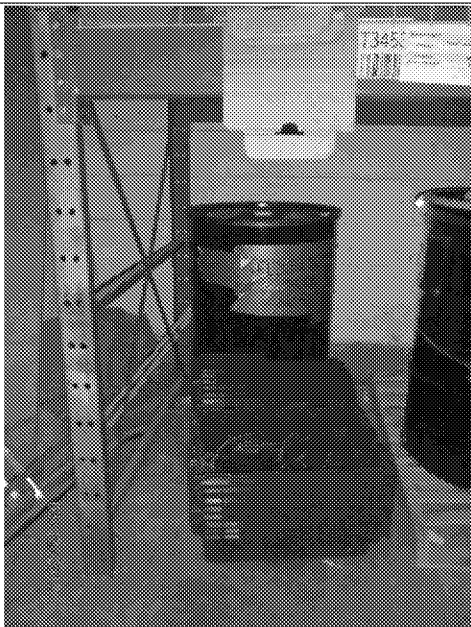
7. Five cardboard boxes of 4-foot used fluorescent lamps not closed;
8. One 55-gallon drum labeled "Fluorescent Bulb Waste" was not marked with an accumulation start date, not labeled with the words "Universal Waste", and not closed;

9. One storage bin containing "Bad Ballasts" not dated or labeled with the words "Universal Waste";
10. Two 8-foot cardboard boxes of used fluorescent lamps were not closed, marked with accumulation start dates, or labeled with the words "Universal Waste"; and

Photograph #17 – Chemical Storage – Universal waste lamp drum and spent ballast container
